# Effect of Elevated Temperature and High Vibration on Centrifugal Gas Pump Separator of Oil Mine Submerged in Salt Water

## Abstract

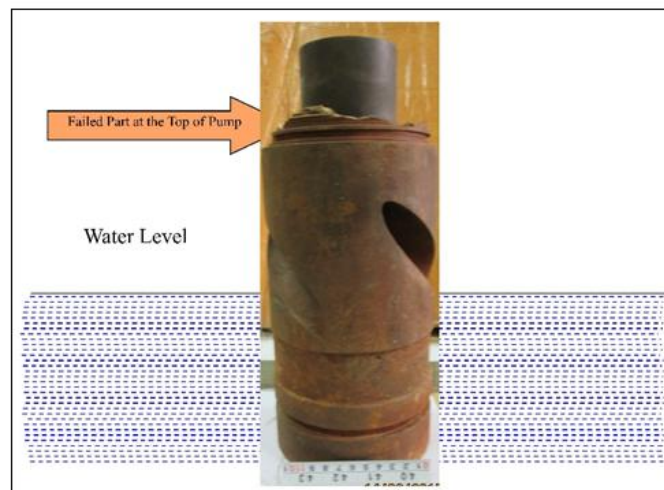
Centrifugal oil lift pump was received the as shown in Fig-2. It is apparent that the upper part is failed due to unknown several reasons. Therefore it is necessary to analyze the material to determine the reasons behind the failure.

**Fig-2: The as-received centrifugal Lift gas separator**

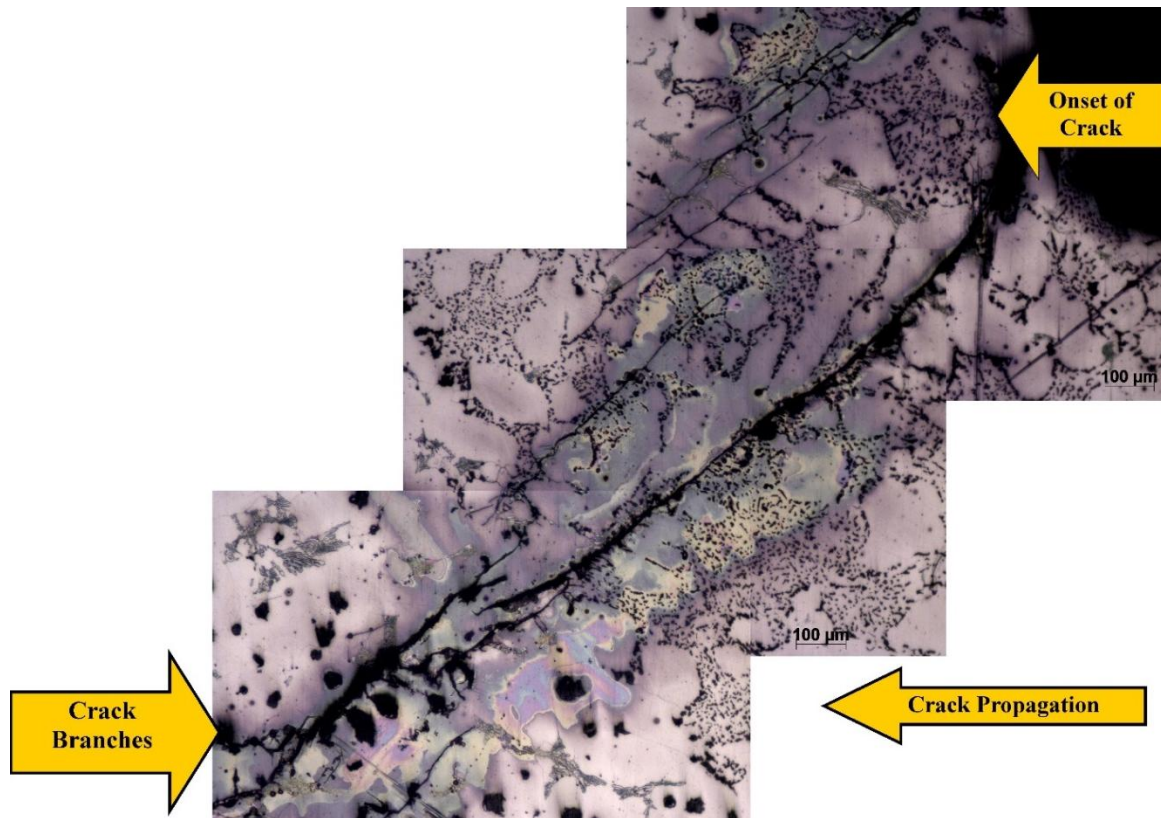
Figure-3 demonstrates the path of cracks starting from the broken edge at the top of pump. Figure-4 shows micro cracks starting from graphite and spread in the matrix.

Fig-3: General view demonstrating the cracks started from the Chunky graphite at the edge coinciding with the matrix

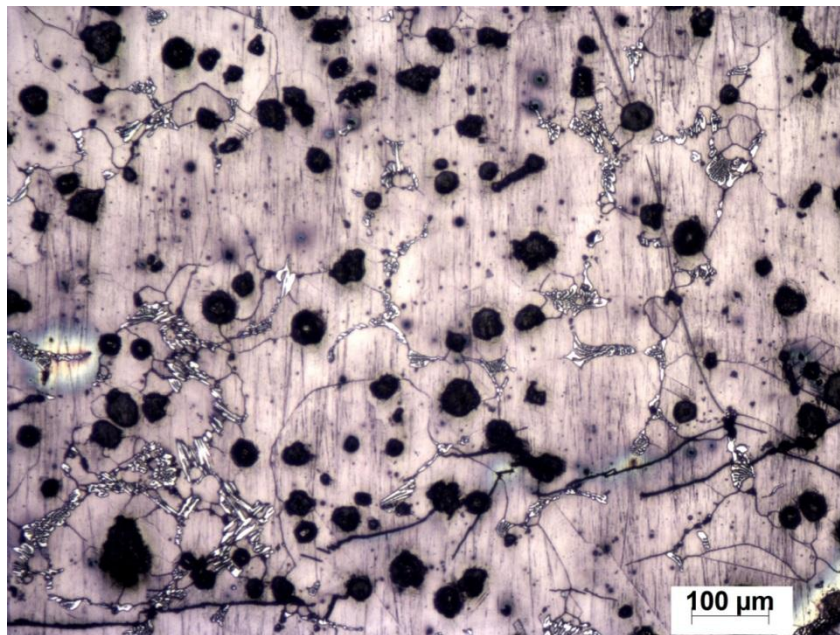
Fig-4: Transgranular crack coinciding with the metal matrix, graphite and carbides due to vibration

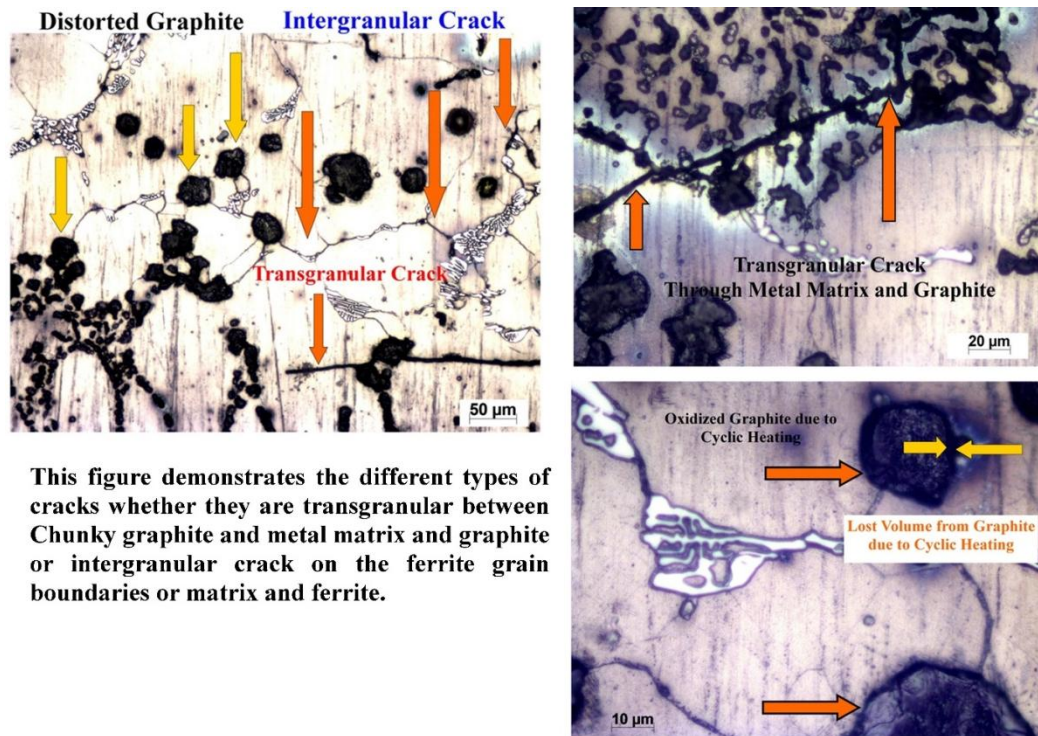
This figure demonstrates the different types of cracks whether they are transgranular between Chunky graphite and metal matrix and graphite or intergranular crack on the ferrite grain boundaries or matrix and ferrite.

**Fig-5: General view of optical microstructure showing the path of cracks through the graphite and matrix, also the graphite shapes after distortion due to heat and oxidation as well as segregated carbides on the cracks type transgranular or intergranular**

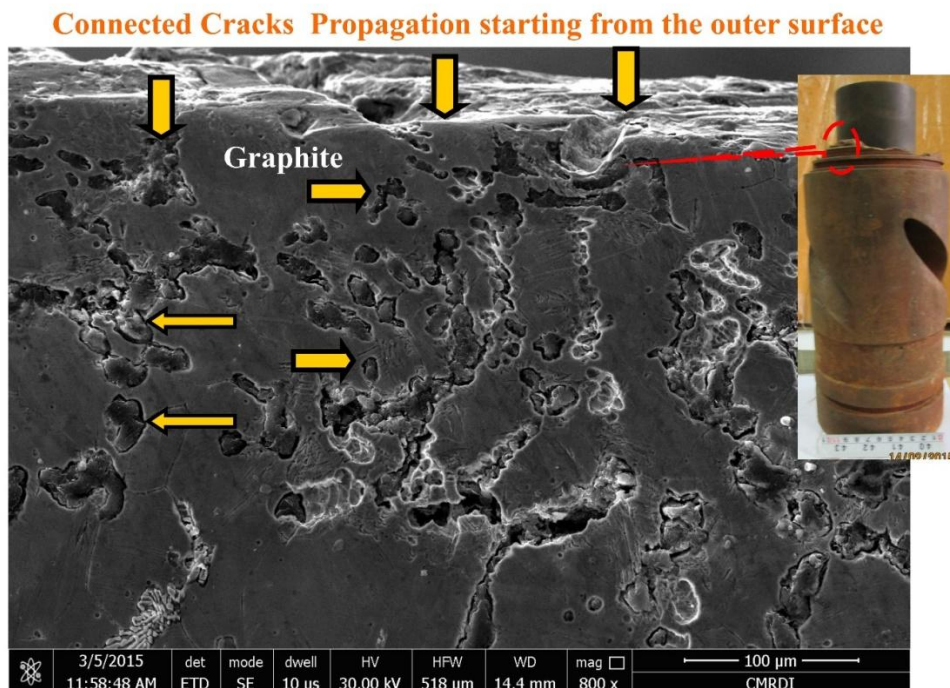
Figure-6 is the SEM microstructure of the edge of the upper part of the failed body for pump. It exhibits the graphite of Chunky type (fine carbides) inside the cast iron matrix. However, it is clear that the graphite is decreased in its volume due to pump circumstances

(heat and vibration). This failure was because pump was working at elevated temperature and vibration without cooling of water which leads to oxidation of graphite).

**Fig-6: General view of the outer surface and cross-sectional area demonstrating the fatigue after several cyclic heating**

Figure-6 shows the graphite of the outer surface of the oil pump at high magnification. It is apparent that the oxidation decreases the graphite size and made the metal matrix like connected caves. Figure-6 also demonstrates the existence of slip bands due vibration which highly decreases the fatigue life of the body and they are catastrophic source for crack initiation. It is also noticed that the slip bands of deformation are located near the graphite in the ductile

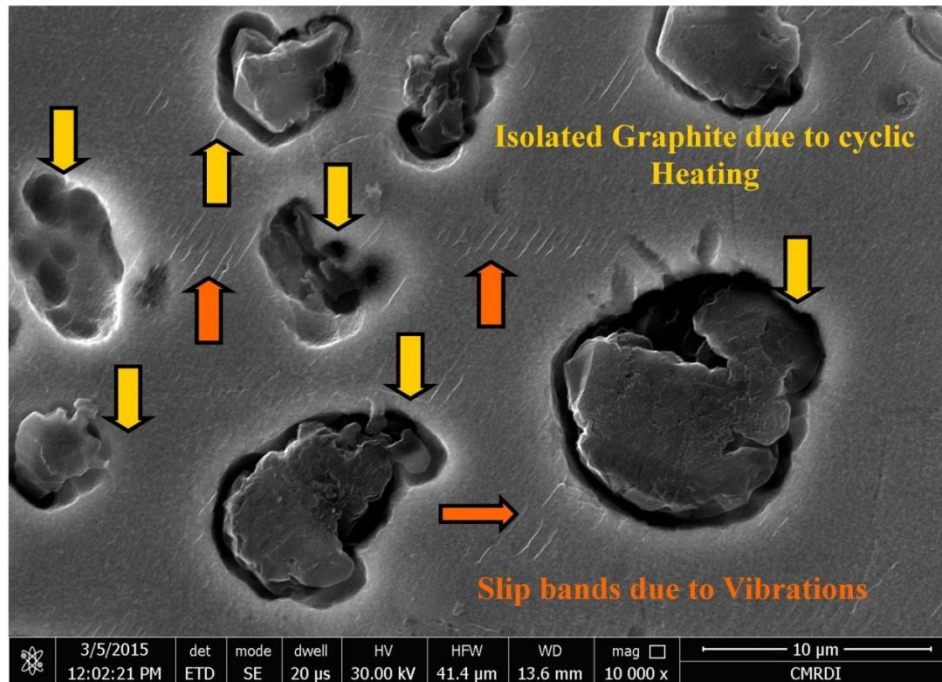
**Fig-7: Details of graphite showing the slip bands**

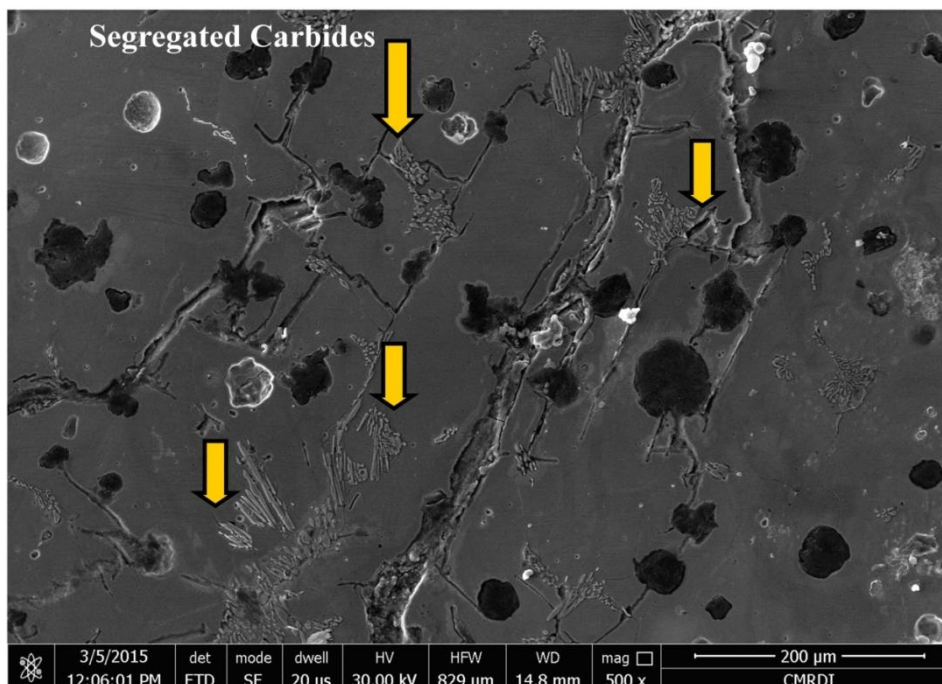
**Fig-8: General view of different cracks, graphite and carbides segregated**

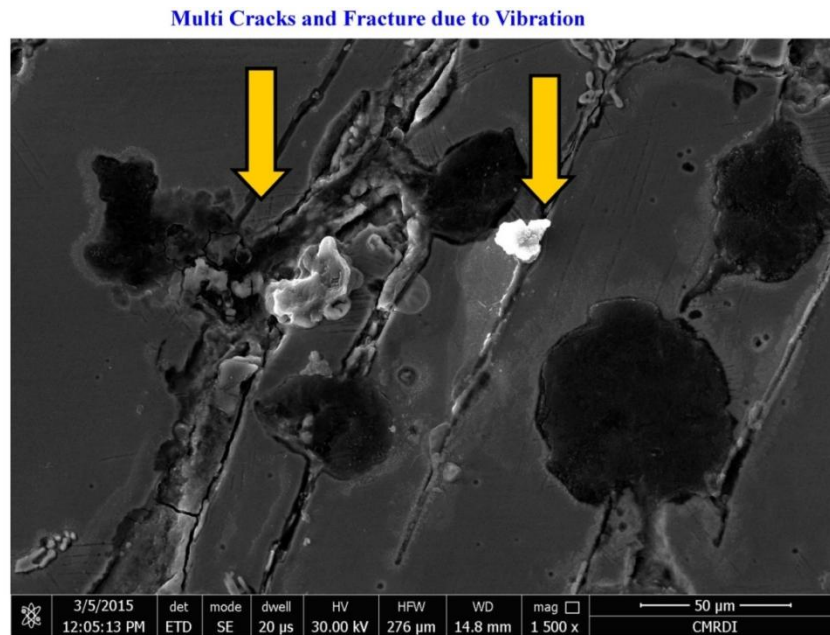
**Fig-9: Details of different cracks passing through the matrix and graphite contaminated with chemicals**

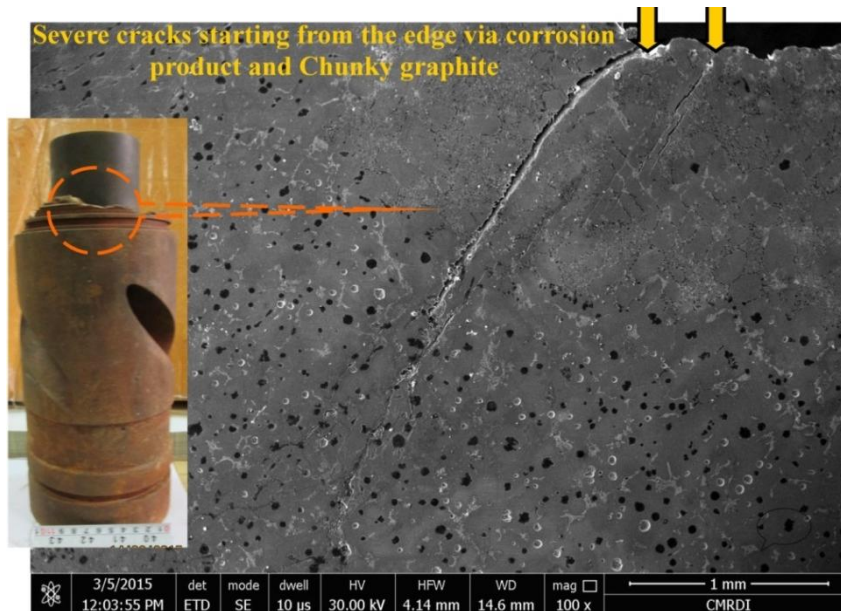
**Fig-10: Catastrophic cracks due to vibration at elevated temperature starting from the upper part surface**

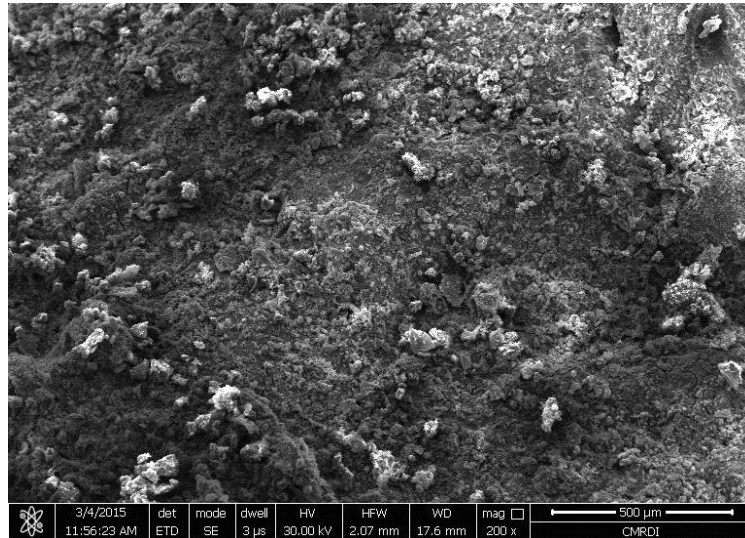
Fig-11 is a general view of the chemical product of failed surface. Fig-12 demonstrates at relatively high magnification the crystals of salts attacking the surface of material. Fig-13 show a general view of the corroded surface while Fig-14 shows the chemical product which is embedded into crack of the upper surface of failure or side wall. Fig-15 emphasizes the existence of salt crystal. Fig-16 illustrates the chemical product on the surface of failure, it is clear that the surface was subjected to sodium chloride due to using hard water of high salinity. It also demonstrates that the surface was at elevated temperature producing two types of iron carbides. Fig-17 provides the different phases of the corrosion products. It is apparent that the cast iron material used in this pump is austenitic one.

**Fig-11: General view of the cracked surface of the body of the pump showing the chemical product on the corroded surface**

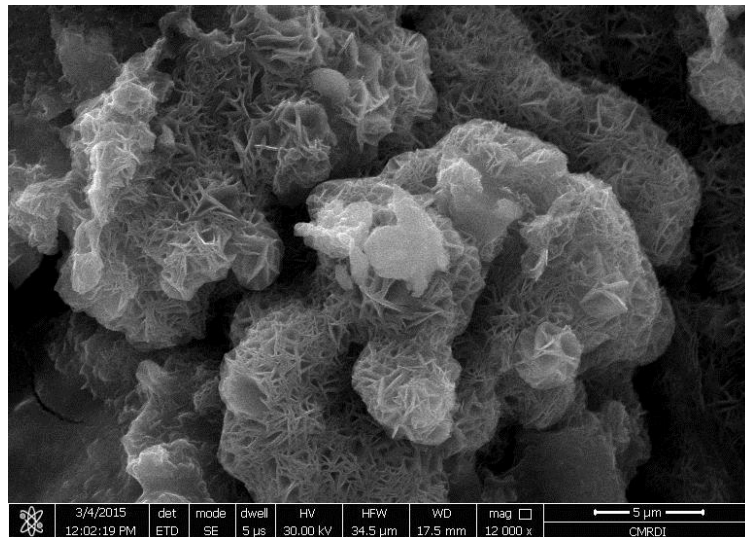
**Fig-12: Corroded surface details demonstrating the crystals of salts**

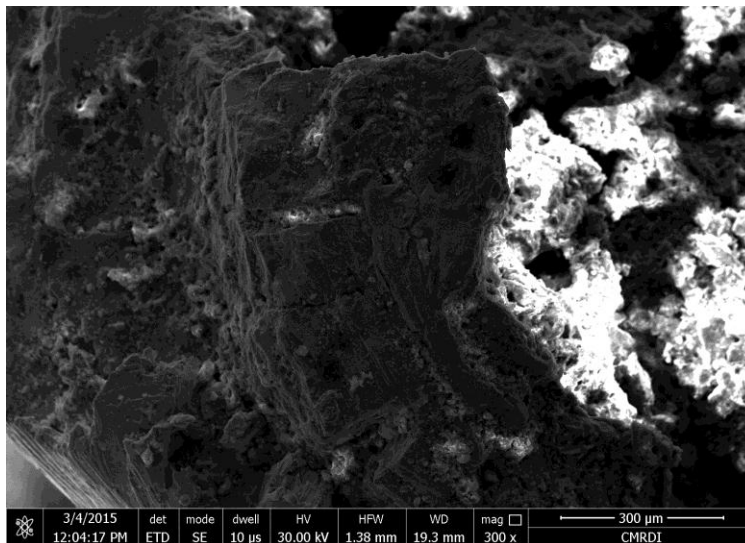
**Fig-13: General view of the chemical attack on the fracture surface**

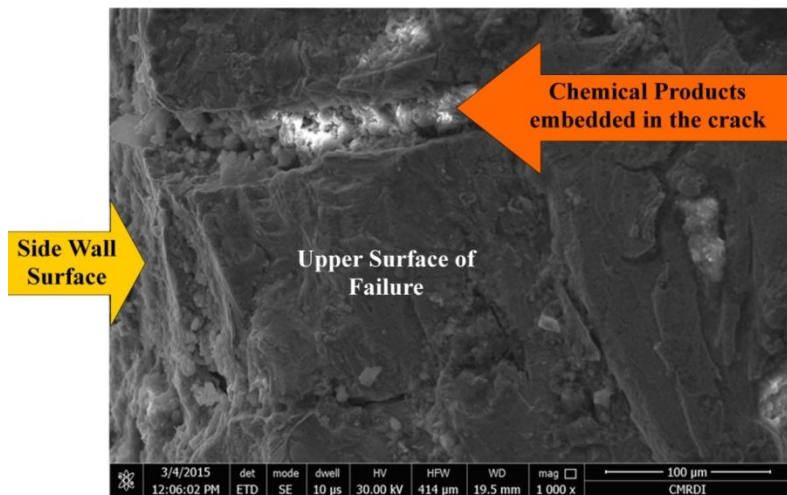
Fig-14: Fracture surface corroded and the chemicals penetrated through the cracks

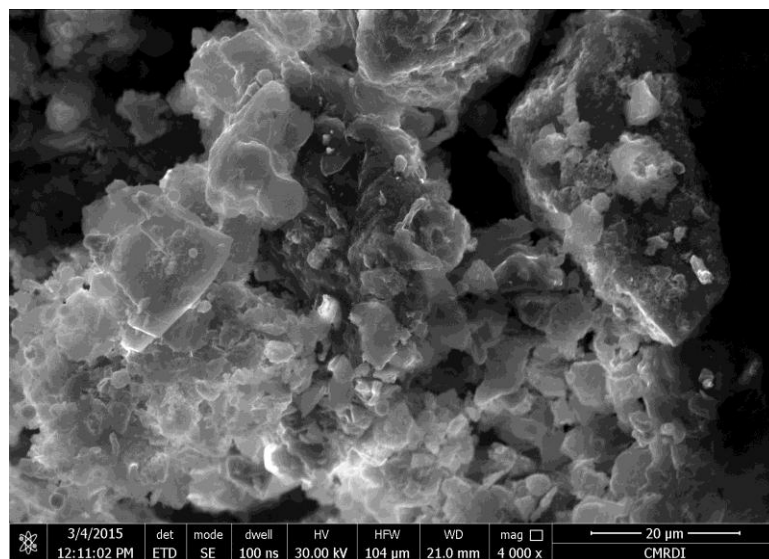
Fig-15: Showing the crystals of the chemicals attacking the fracture surface

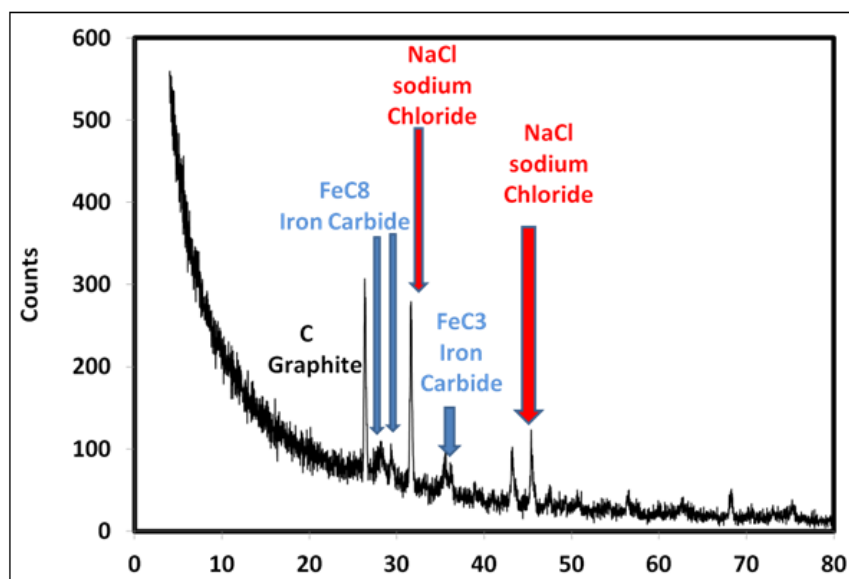
Fig-16: X-ray diffraction of chemical compound attached the fracture surface

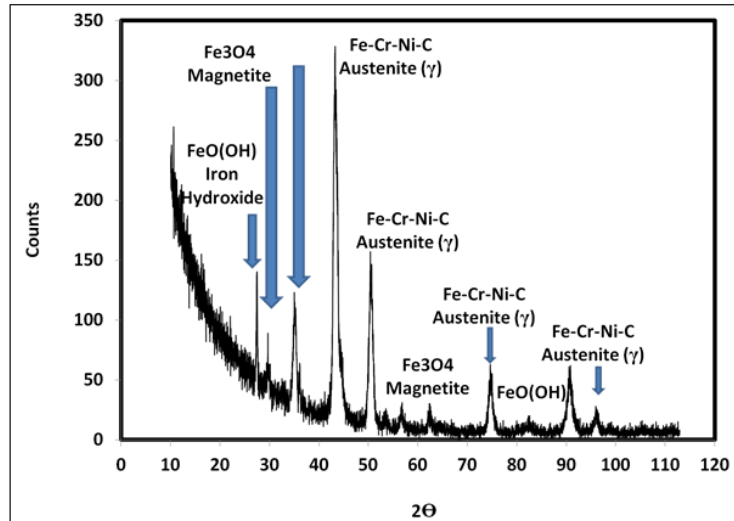
Fig.17 X-ray diffraction of different phases

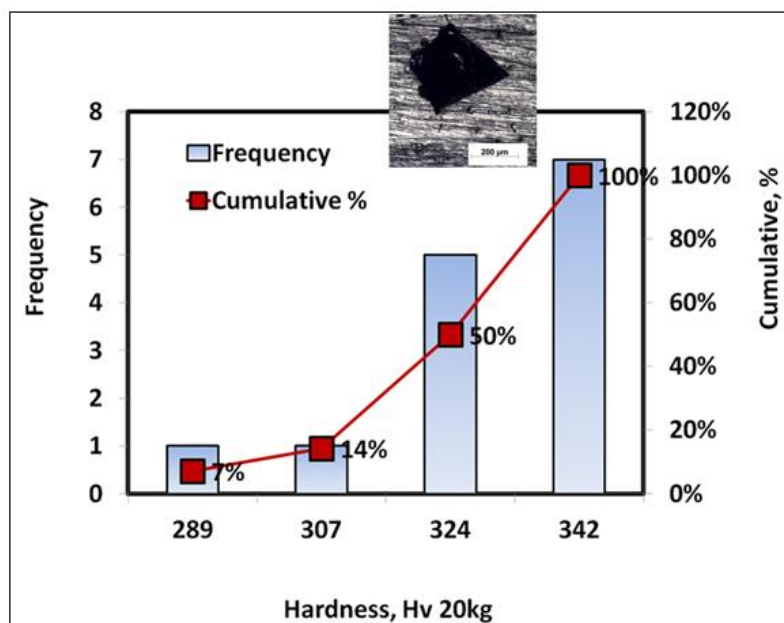
Furthermore, it proves that the material was attacked by hydrogen forming iron hydroxide. Table-2 and Fig-18 provide the hardness distribution on the failed surface. It is clear that the average hardness is 326Hv. On the other hand, the lower part of the pump (base) shows the hardness distribution of the pump surface in Table-3 and Fig-19. The average hardness of the lower base of the pump is 174Hv. This difference of hardness of one body of the pump is due to submerging of the lower part in water which cooled the base of the pump and prevented the aging process and the distortion of the graphite. While the upper part (failed) was without water therefore the aging process affected graphite and increased the hardness due to carbon diffusion.

Fig-18: Hardness distribution of failed upper part

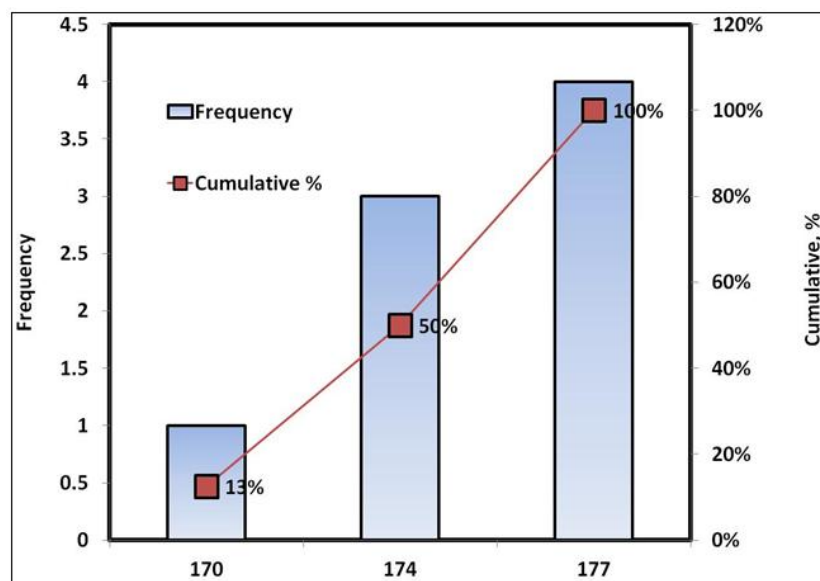
**Fig-19: Hardness distribution of the base metal**

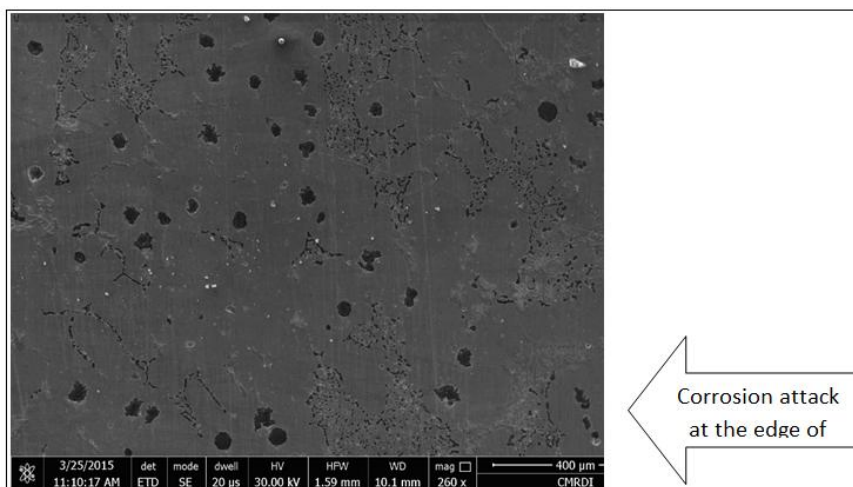
Figures 20, 21, 22 and 23 show that the graphite of the base of the pump is sound without any distortion in graphite shapes. This emphasizes that the metal of the pump base was submerged in water preventing the aging phenomena to happen and the graphite distortion to occur.

**Fig-20: General view of the graphite of the base of the pump (submerged in salty water)**

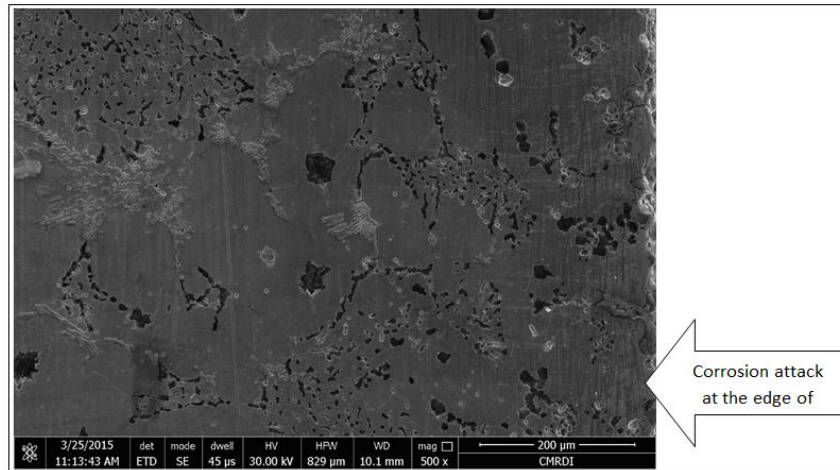
**Fig-21: General view of the graphite of the base of the pump (submerged in salty water) at different zone**

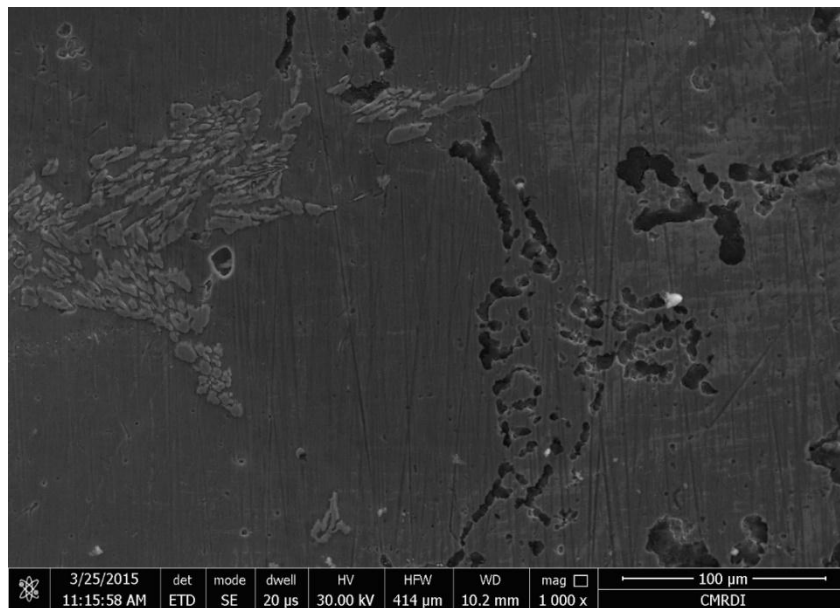
**Fig-22: View of Chunky graphite showing sound graphite**

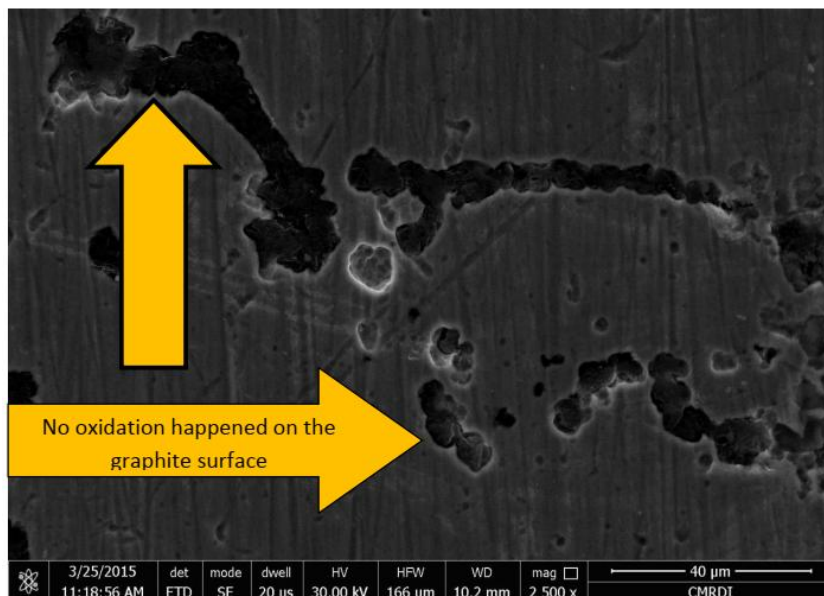
**Fig-23: Showing the Chunky graphite at relatively high magnification**
