Localization of Broken Surgical Bur in the Third Molar Socket and Its Retrieval

Original Research Article

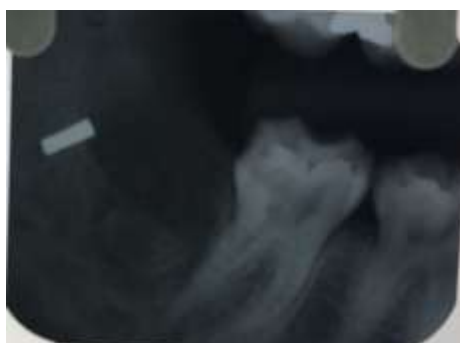
The possible causes of burs and other dental instruments breakage during surgical procedures can be due to excessive stress, manufacturing defects, fatigue of instruments, rust or poor handling [1]. Excessive and incorrect sterilization is another reason for this. Use of the autoclave without the anticorrosive pre-treatment

affects the integrity of stainless steel dental instruments and can cause fracture [2].

Fig-1: IOPA x-ray showing surgical burr tip in the third molar socket

Thus clinicians must pay definite attention to instruments being used in areas of questionable visibility and avoiding too much pressure on the hand piece burr during bone removal or tooth sectioning.

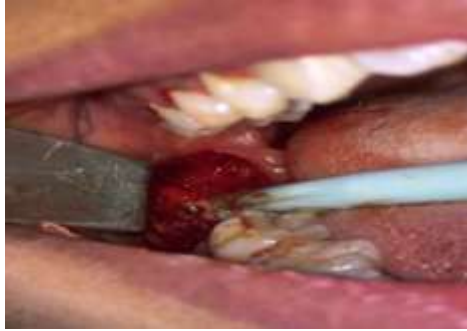
Fig-2: Localization of the surgical burr tip after flap reflection
