# Retrieval of Fractured Rotary Instrument from Root Canal: A Case Report

## CASE REPORT

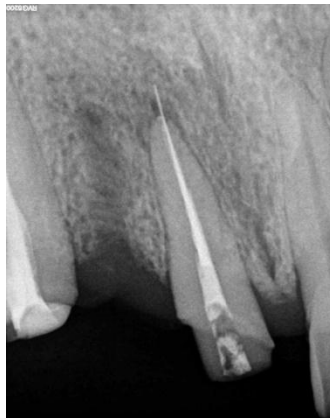
**Fig-1: Pre-operative radiograph showing fractured instrument extending beyond the canal**

A 35 year old female patient reported to Department of Conservative dentistry and Endodontics with the chief complaint of pain in upper front region of the jaw since 2 weeks. The patient's dental history indicated that the tooth had undergone root canal treatment 1 month back. During clinical examination the tooth was sensitive to percussion and a temporary closed dressing was evident. Intra-oral periapical (IOPA) radiograph was taken and it was revealed that there is root canal treatment performed on the right maxillary central incisor (tooth no. 11) also the separated instrument in the canal extending beyond the apex (Figure-1). Local anaesthesia was administered after rinsing the patient's mouth with 0.2% chlorhexidine and isolation was done with rubber dam. Temporary dressing was taken out and gutta-percha was removed from the canal using H-files, modified Gates Glidden drill (size 3, Dentsply Maillefer, Ballaigues, Switzerland) was used to create a staging platform. After staging, ET25 tip of Endo Success™ Retreatment ultrasonic file (Figure-2) was attached to

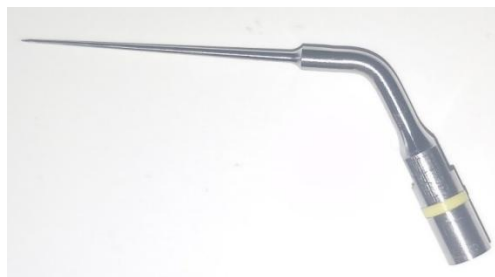
**Fig-2: ET25 ultrasonic tip**

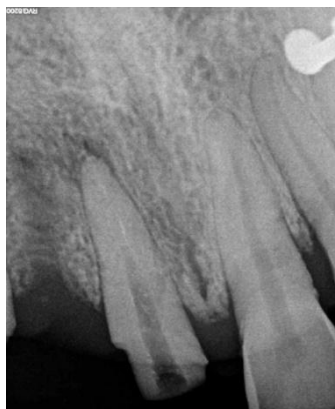
**Fig-3: Radiograph showing retrieval of fractured instrument from the root canal**

the ultrasonic device and was activated first at the inner dentinal wall of the canal to create approximately 1.0 mm deep pocket from the severed surface of the file fragment. EDTA solution was introduced in the canal so that the cavitation and acoustic streaming effect of ultrasonics has been enhanced. Ultrasonic vibration was applied and moved in “push and pull” motions between the fragment and the inner wall of the canal until the separated instrument jumped out of the canal. A radiograph was taken to confirm retrieval of the file fragment (Figure-3). The retrieved file fragment was approximately 10 mm long (Figure-4). After instrument retrieval, working length was determined using

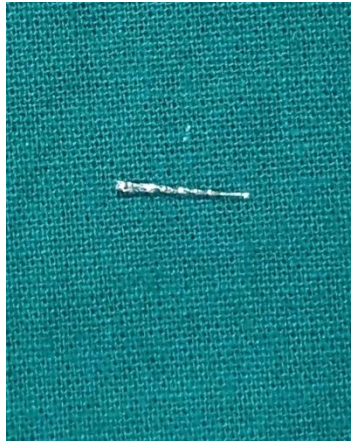
**Fig-4: Retrieved file fragment approximately 10 mm long**

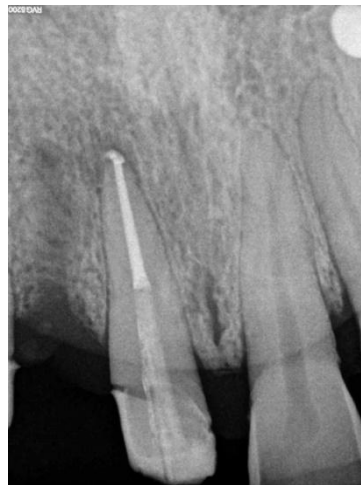
**Fig-5: Post-operative radiograph**

radiograph and electronic apex locator (Propex, Dentsply, Maillefer, Ballaigues, Switzerland). Chemo-mechanical preparation was performed using rotary NiTi files (ProTaper, Dentsply Maillefer, Ballaigues, Switzerland). 5.25% sodium hypochlorite and 2% chlorohexidine were used for irrigating the root canals and calcium hydroxide as an intracanal medicament was placed. In the second visit, obturation was carried out by warm vertical compaction technique using gutta percha points (ProTaper, Dentsply, Maillefer, Ballaigues, Switzerland) and Sealapex sealer (Kerr, SybronEndo) (Figure-5). Fiber post was cemented followed by composite restoration.
