Elevator Tip Retrieval from Periapical Region of Mandibular Molar Socket- A Case Report

In this present scenario of oral surgical intervention proper instrumentation and technique holds a superior position which comes with experience of the operator, despite that, some accidents may happen when defective instruments are unknowingly used. This article reports a case of a retained fractured dental elevator tip during surgical extraction of impacted mandibular third molar. The vast majority of cases reported in the literature occur during endodontic treatment, and this is an accepted common risk within the endodontic specialty. However, there is very little literature regarding instrument fracture and management of cases following simple or complex exodontia. Although this is a rare incident, it reinforces the importance of checking instruments pre- and post-surgery by both the dental surgeon and assistants.

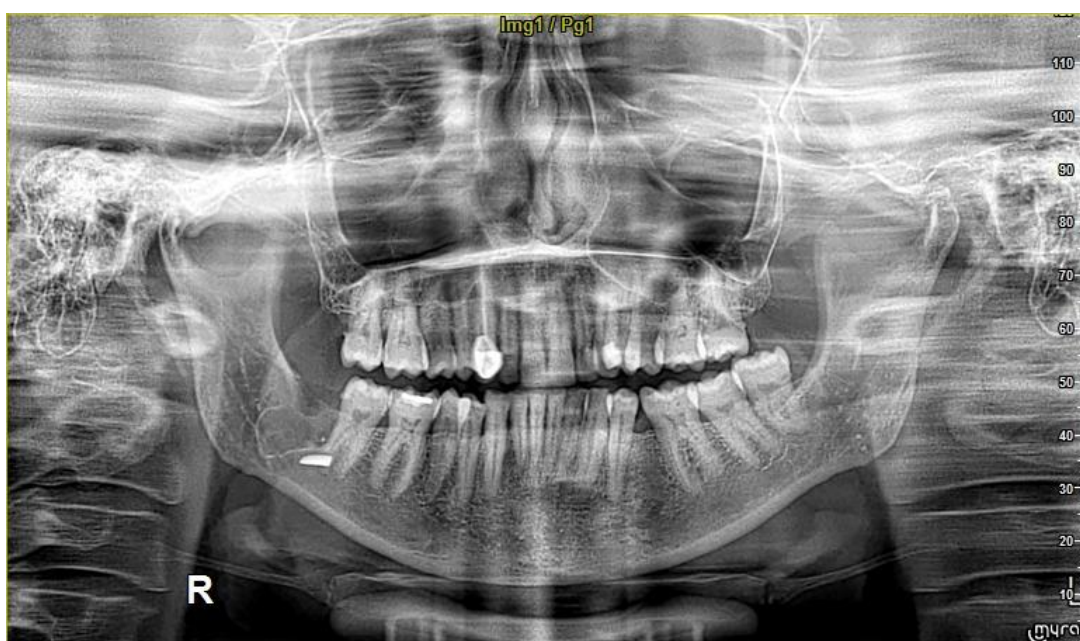
not possible. Roots of sectioned third molar were removed from the socket using coupland elevator. Primary closure was done and patient was asked for orthopantomogram radiograph. Incidence of broken instrument was informed to the patient and she was assured about the outcome and removal after radiographic confirmation. On radiographic interpretation it was observed that the metallic tip was positioned in an oblique fashion with the tip directed distally (Figure-1). The tip of the elevator had a good

clearance with the Inferior Alveolar Nerve. Metallic tip was lying close to distal root apex of second molar. Second surgery was planned for removal of broken tip under guidance of radiograph and antibiotic coverage. Tip as mentioned earlier was localised near the distal root tip of second molar in buccal position. Extraction socket was explored and metallic tip was retrieved. The tip was retrieved using artery forceps and the area thoroughly curetted. The tissue was closed with sutures. The healing was uneventful (Figure 2 & 3).

Fig-1: OPG showing broken elevator tip on distal of periapical region of 47

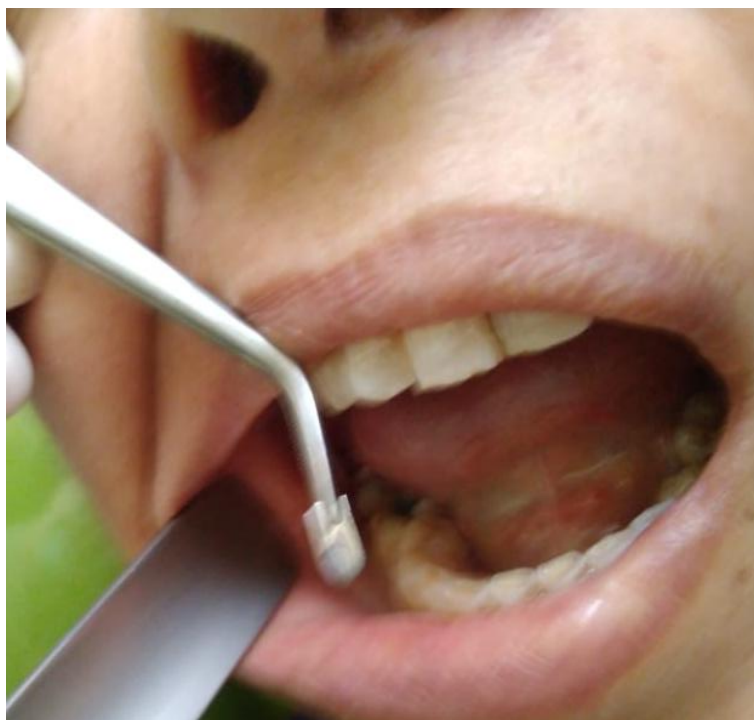
Fig-2: Operative Clinical View of tip removed

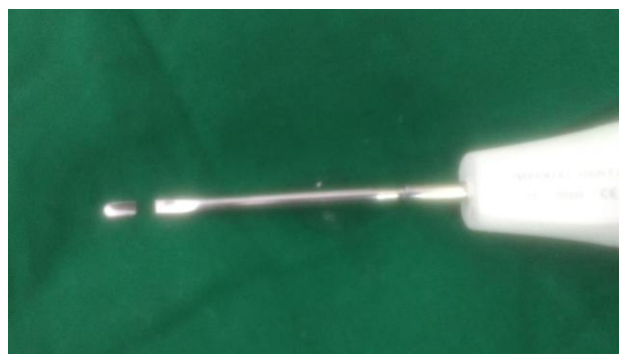
Fig-3: Broken tip fragment of elevator
